The Effect of Humidity on the Reliability of a Surface Micromachined Microengine

Danelle M. Tanner, Jeremy A. Walraven, Lloyd W. Irwin, Michael T. Dugger,
Norman F. Smith, William P. Eaton, William M. Miller, and Samuel L. Miller

Sandia National Laboratories, P.O. Box 5800, MS 1081, Albuquerque, NM 87185-1081
<http://www.mdl.sandia.gov/Micromachine>
email: tannerdm@sandia.gov

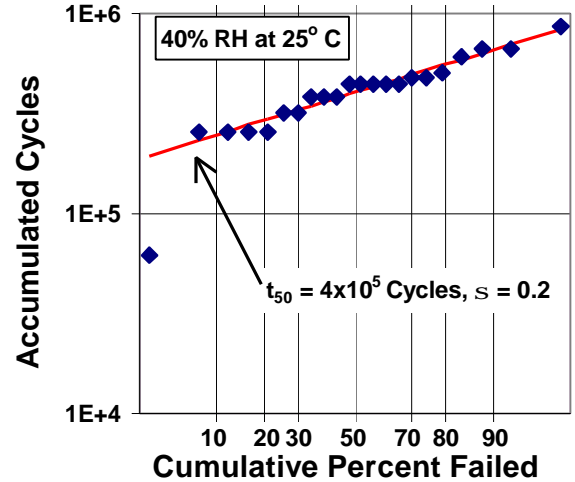
The data from each of the experiments could be described by a simple unimodal distribution such as seen in Figure 3. The regression analysis yielded a median of 4×10^5 cycles to failure with a correlation coefficient of 0.98. The shape parameter, σ , was determined to be 0.2. The above analysis was completed for each experiment and a value for the median and sigma of each distribution was calculated. We performed nine experiments during which a total of 262 parts failed. A larger number of experiments were performed with the FTS process simply because of their greater availability.

Figure 3. Lognormal distribution of accumulated cycles to failure for the 40% RH stress. The early failure, with less than 10^5 cycles, was omitted from the regression analysis.

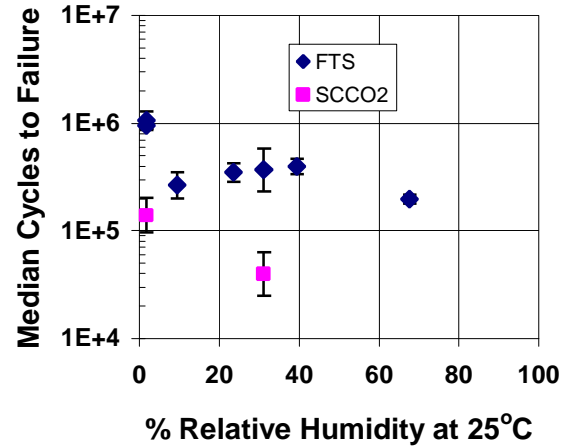
Figure 4. The effect of humidity on the lifetime of the microengines shows a rather flat distribution with the exception near 0%. The y error bars represent 95% confidence bounds. The microengines were stressed with large forces to accelerate failures in these experiments.

shows a rather flat dependence on humidity for the FTS-coated microengines with the exception near 0%. The SCCO₂ data shows the failure roughly an order of magnitude earlier, indicating a less reliable microengine.

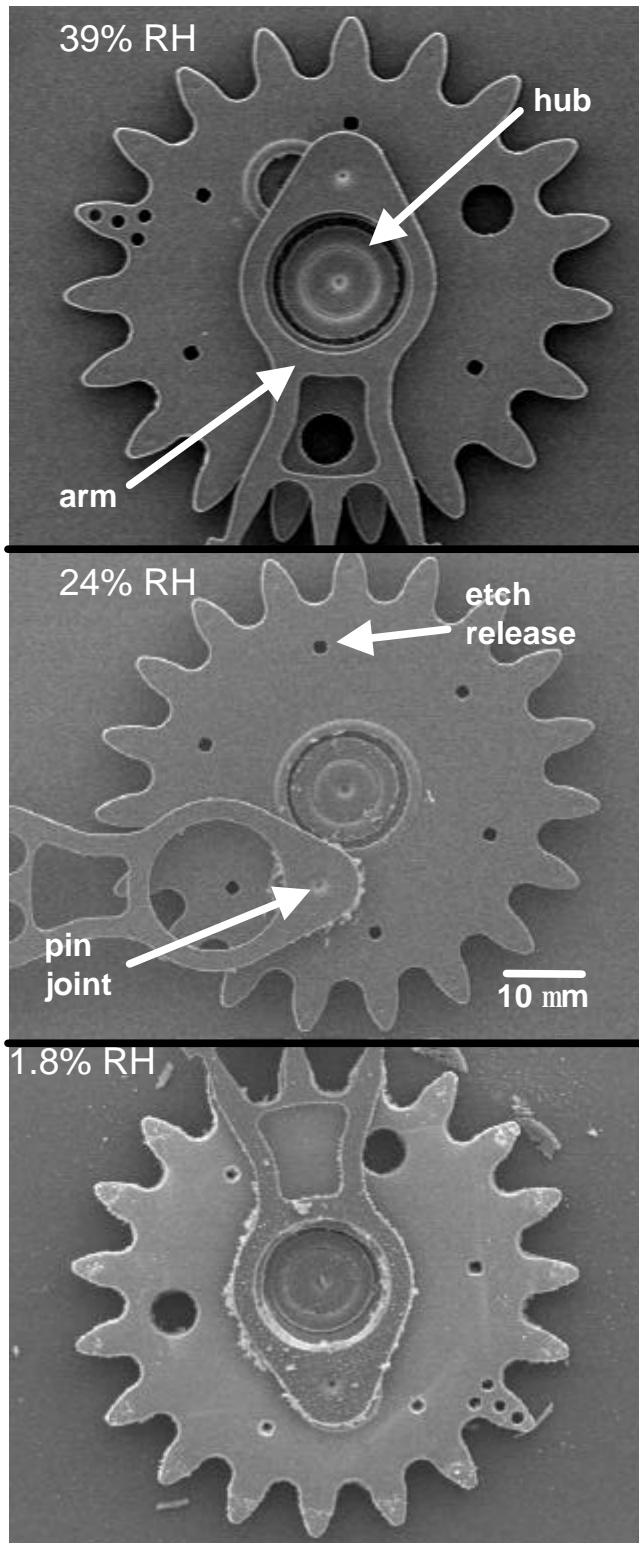
FTS Treatment: The dominant failure mechanism for these microengines has been identified as wear. The major effects of the wear process were either pin joint wear-out causing the linkage arm to break away from the gear or accumulation of wear debris causing the microengine to seize. The overwhelming effect of the humidity was demonstrated by the amount of wear debris observed. The volume of debris increased dramatically as we lowered the humidity. In Figure 5, we show a comparison of the gears of microengines stressed in air environments of 39%, 24%, and 1.8% RH at 25°C. These microengines were stressed to failure at 862,000, 746,000, and 742,000 accumulated cycles, respectively, yet the microengine with the most accumulated cycles has the least amount of wear debris. In the 39% RH case, there is a small amount of debris located around the hub. The 24% RH case shows more noticeable wear debris around the hub and on the linkage arm. The debris in the 1.8% case includes large slivers near the gear teeth. Debris has been thrown out and collected on the hub face, at the tips of the gears, on the linkage arm, in the etch-release holes, and onto the substrate area outside of the gear face. These images are characteristic of observations at different humidity levels.

Figure 5. SEM images of various microengine gears stressed under different humidity conditions 39%, 24%, and 1.8% RH at 25° C. The microengines were stressed for roughly the same number of cycles, but the amount of wear debris for each humidity was dramatically different. (FTS)

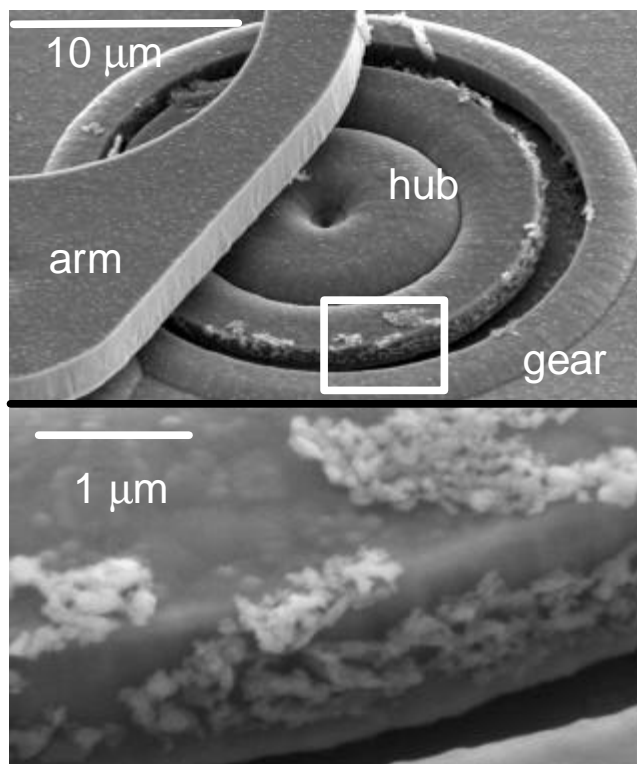
Using a field emission SEM to further magnify and characterize the wear debris, we again noticed a difference between the 39% and the 1.8% RH case. Figure 6 shows a magnified view of the hub of a microengine that failed at 510,000 cycles at 39% RH. The box region has been magnified further to illustrate the debris morphology. The wear debris appears to be 200 to 500 nm agglomerates which string together with other agglomerates to form chains of 1 μ m or longer.

Figure 6. SEM magnified view of the hub region on a microengine that failed at 510,000 accumulated cycles during the 39% humidity test shows the morphology of the wear debris. (FTS)

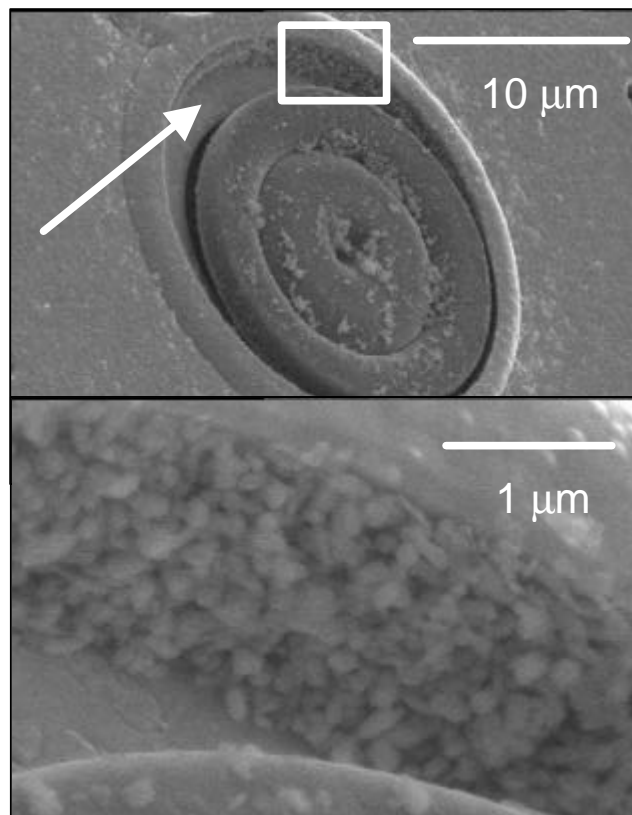
For comparison, we investigated the hub of a microengine stressed to failure after 642,000 cycles in 1.8% RH at 25°C. This hub is shown in Figure 7. The first item to note (indicated by an

arrow) is the radial offset in the gear and hub due to the large amount of wear between the hub and the mating gear. The offset caused a wobble in the motion of the gear at the inspection frequency of 1 Hz. Note also that the entire hub is covered with particulate wear debris. This is shown more fully in the lower image of Figure 7, which is a higher magnification of the box region. There are no stringy agglomerates in the 1.8% RH case.

Figure 7. SEM magnified view of the inner gear region on a microengine stressed to failure after 642,000 cycles at 1.8% RH. The wear debris formed particulate matter, each smaller than 100 nm.

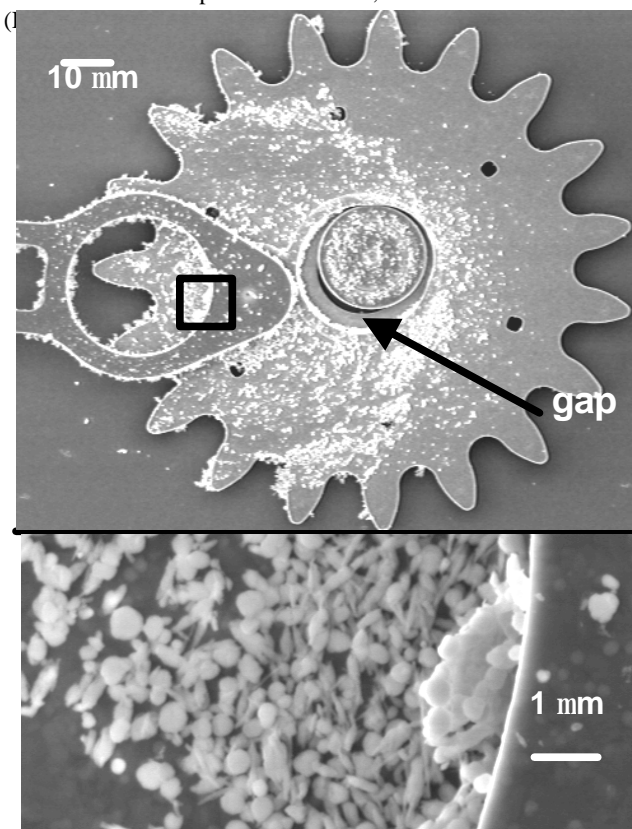
SCCO₂ Treatment: Just as in the FTS treatment, the dominant failure mechanism was associated with wear. As shown in Figure 8, the amount of wear debris on the face of the gear far exceeded that observed in the FTS case at the humidity level of 1.8% RH. This engine failed at 600,000 cycles. The gap around the hub was an indication of severe wear.

Figure 8. SEM image of a microengine that failed at 600,000 cycles at 1.8% RH illustrates the wear debris produced. The gap near the hub is an indication of severe wear. Note the morphology of the wear debris in the lower magnified image. (SCCO₂)

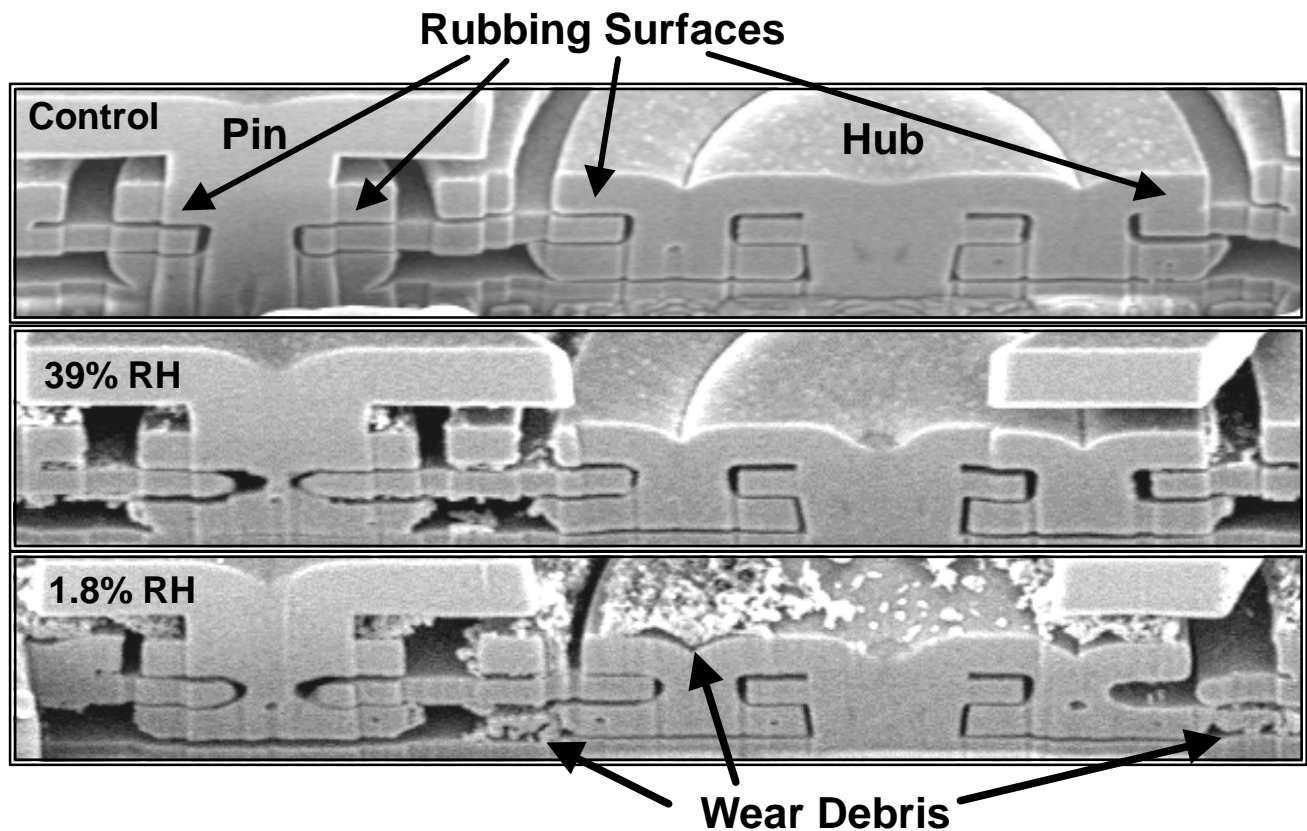
FTS Treatment: To investigate the effect of wear, FIB cross sections were performed on a sample from each humidity level. Shown in Figure 9 are cross sections taken from a control (top), 39% RH (middle), and 1.8% RH (bottom) samples. The control sample was tested for functionality, but was not stressed. Because debris is not shown in the control sample we believe the debris was caused by wear, not the FIB cut. The 39% RH microengine was stressed to failure at 606,000 cycles and the 1.8% RH microengine

Figure 9. SEM images of the control, the 39% RH sample and the 1.8% RH sample illustrate the amount of wear debris created in each experiment. Arrows indicate the rubbing surfaces. In both stressed samples, the pin joint has been worn down from its fabricated 3 μm diameter. (FTS)

was stressed to failure at 542,000 cycles. In the 39% RH case, we observed mostly pin joint wear as shown with the notched diameter. The wear of the pin joint was accompanied by a reduction in the pin joint opening, probably due to a buildup of debris. For the 1.8% RH experiment the wear was observed in both the pin joint and the hub. The pin joint diameter eventually broke in the majority of samples tested (32 times out of 50 samples) for the 1.8% case.

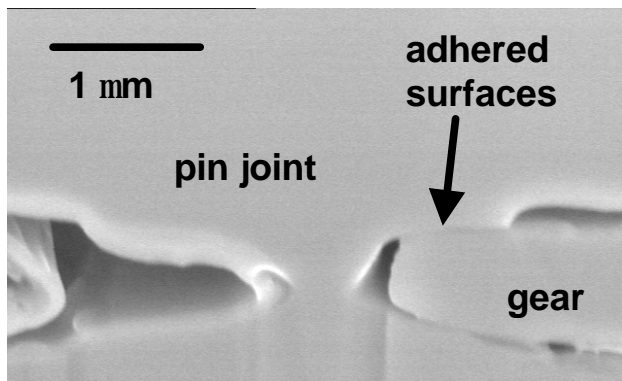
Figure 10. SEM magnified view of the pin joint region in a FIB cross section shows the area where the two surfaces adhered causing the microengine to seize. This microengine was tested at 10% RH at 25°C. (FTS)

Using high resolution SEM, closer observation of the pin joint of the 10% RH microengine stressed to failure at 510,000 cycles reveals adhesion of the wearing surfaces (Figure 10). This was our

first observation of adhered surfaces, which yielded clear evidence of the cause of failure. As indicated on the right hand side of Figure 10, the adhered region is approximately 0.7 μm long.

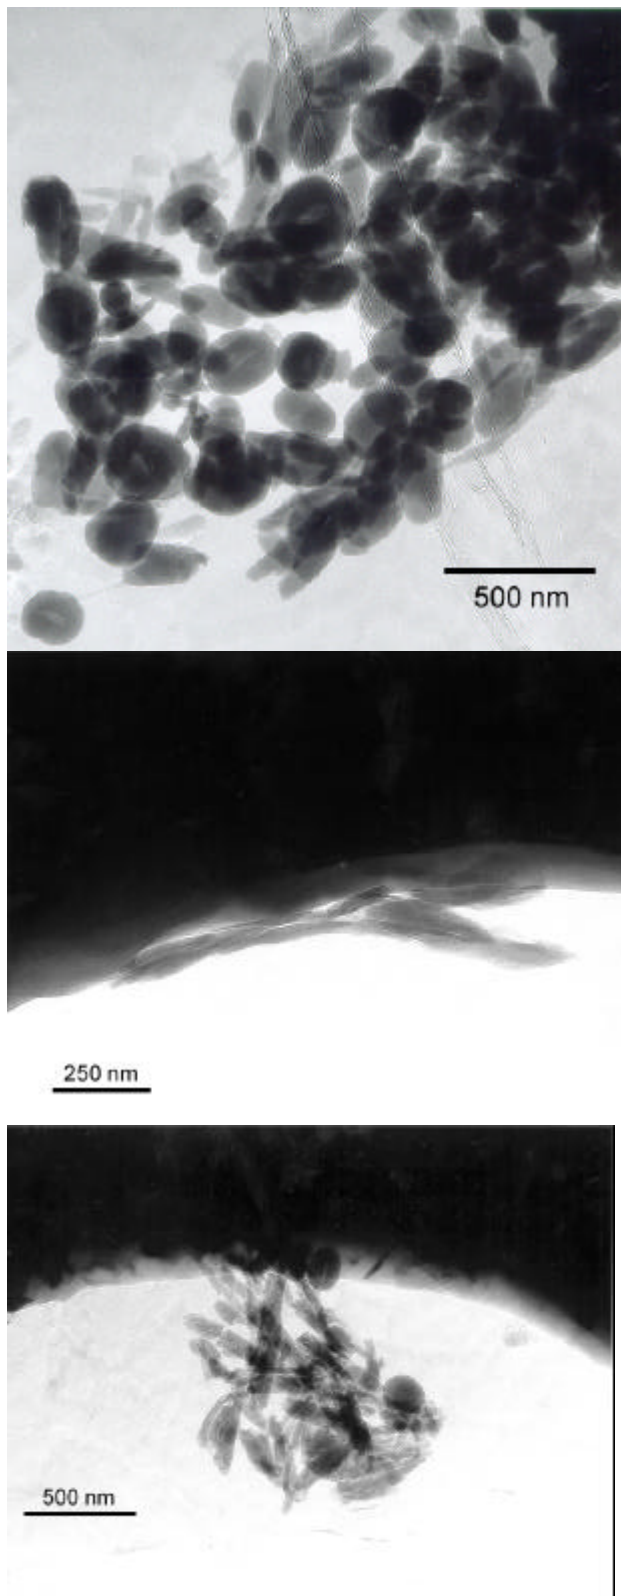
Gears from two microengines tested to failure at 1.8% RH were examined in plan-view. These engines accumulated 642,000 and 742,000 cycles prior to failure. As illustrated in the SEM micrograph of Figure 5, large amounts of wear debris are produced in this environment. The analysis of wear debris found outside the gear, adhering to the gear teeth, and inside etch release holes of both gears showed the debris to be either spherical or rod-like in geometry. Figure 11 shows spherical particles ranging from 100 nm to ~250 nm in diameter. Also shown are rod-like debris particles with diameters ranging from 20 to 50 nm and lengths up to 0.5 μm . The morphology of both the spherical and rod-like structures was

Figure 11. Spherical and rod-like debris morphologies from outside the gear (top), adhering to the gear tooth (middle) and inside an etch release hole (bottom). Note the region inside the spherical debris. (FTS)

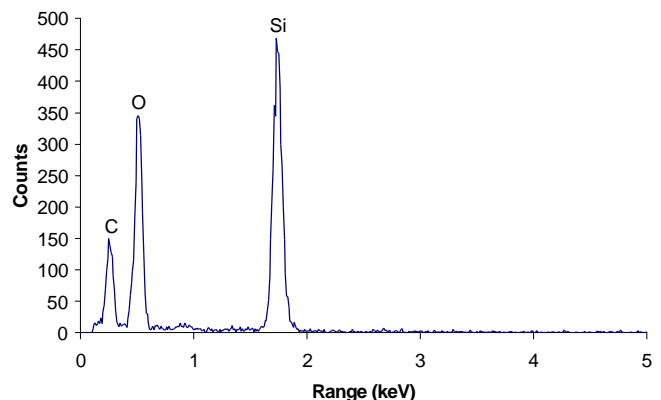
Using TEM in conjunction with EDS, the wear debris has been identified as amorphous oxidized silicon with either spherical or rod-like morphologies. EDS spectrums taken from wear debris found outside the gear, adhering to the gear teeth, and inside etch release holes revealed high concentrations of carbon, oxygen and silicon. Diffraction patterns (not shown) taken from these locations showed broad ring-like patterns typical of amorphous materials. The lack of diffraction spots or speckled rings from these areas indicate no polysilicon was worn directly away from the hub or pin joint regions during testing. Figure 12 illustrates an EDS spectrum typical of debris analyzed from all three regions. High concentrations of carbon result from the thin carbon film used for sample preparation.

Figure 12. EDS spectra of wear debris found outside the gear. Note the strong presence of oxygen and silicon.

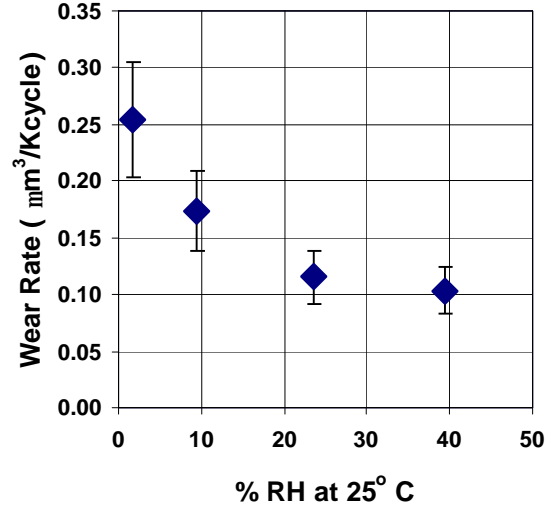
The locations exhibiting the most wear were the hub and pin joint areas so we made our estimates there. Measurements of the diameter of worn hubs, gears, and pin joints were made. The cross sectional area was calculated and compared to the control to yield a value for worn area. This value was then multiplied by the thickness to yield the volume of the material worn away. The technique assumes that the wear is symmetrical around the hub and pin joint. We estimated the error in the technique as $\pm 20\%$ of the calculated worn area. The wear volume was normalized by the total number of cycles to failure to yield wear rate which is shown in Figure 13 as a function of % RH at 25°C.

The wear rate shown in Figure 13 agrees with studies of a SiC/SiC system [20] where the decrease in wear rate has been attributed to a tribochemical reaction leading to the formation of a protective film of hydrated amorphous silica. Silicon nitride sliding on silicon nitride was also investigated [21] and the main mechanism of wear was the tribochemical oxidation of the silicon nitride to form silicon oxide. The wear rate increased in drier conditions in the silicon nitride case also.

Figure 13. This plot of wear rate of FTS-coated microengines as a function of humidity shows the increase in wear rate as humidity decreases. (FTS)
